# CITY OF PORT ANGELES

Lincoln Street - Peabody Creek Culvert

# PEABODY CREEK LINCOLN ST CULVERT

# PEABODY CREEK / LINCOLN STREET CULVERT REHAB

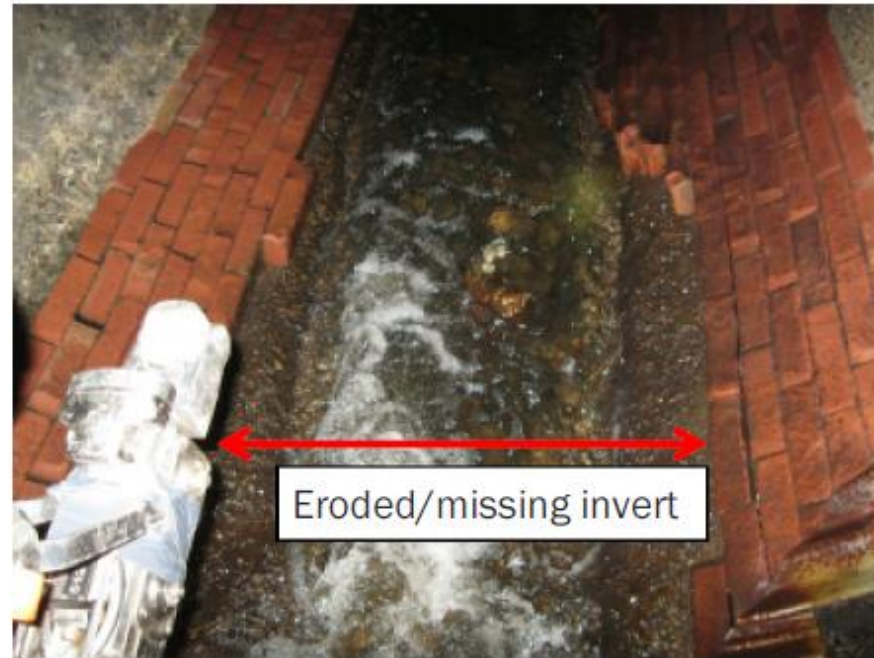
Figure 2-3. Ellipse: missing invert (170')

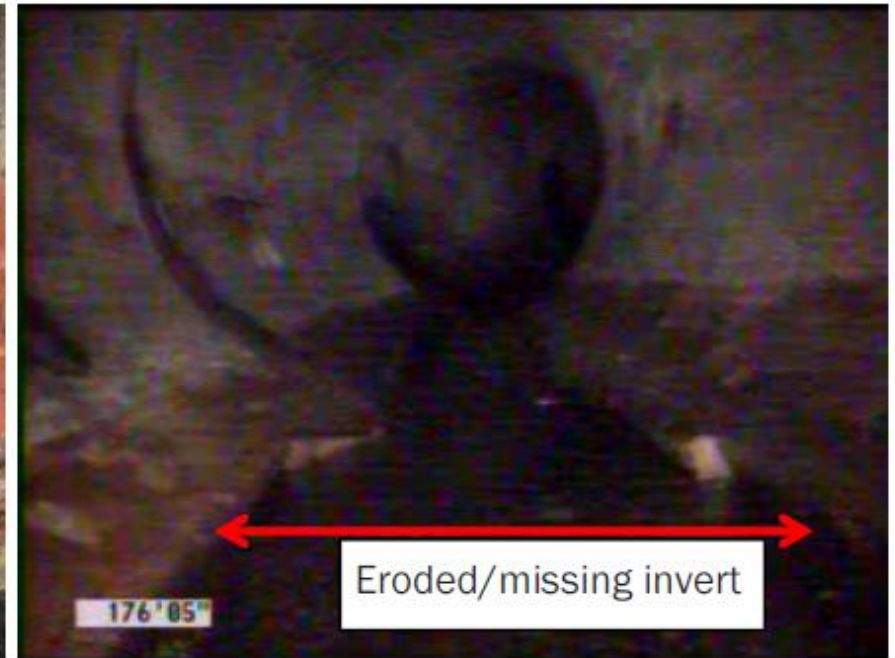
Figure 2-4. Ellipse: missing invert (176')

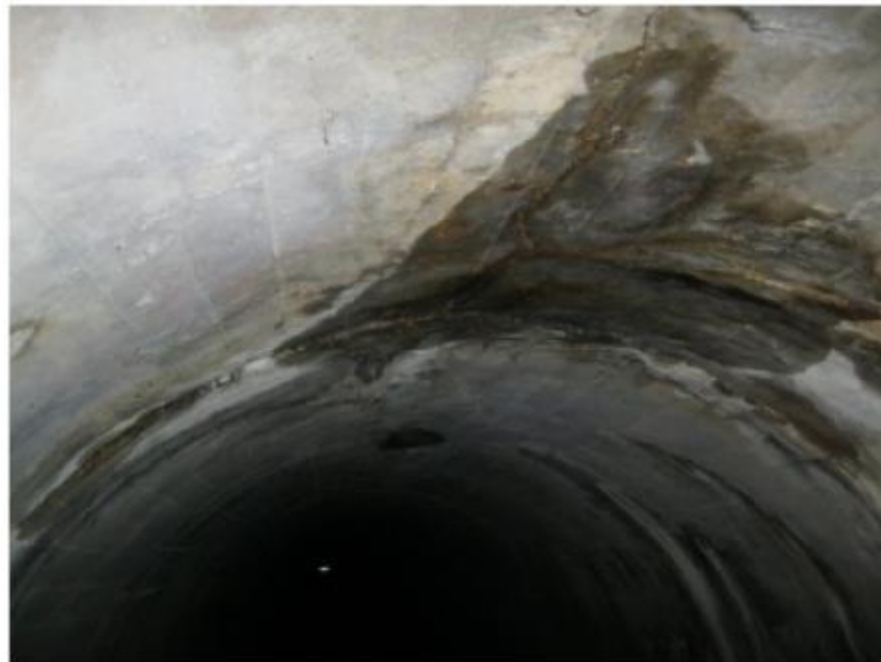
Figure 2-9. Ellipse: crack with infiltration (335')

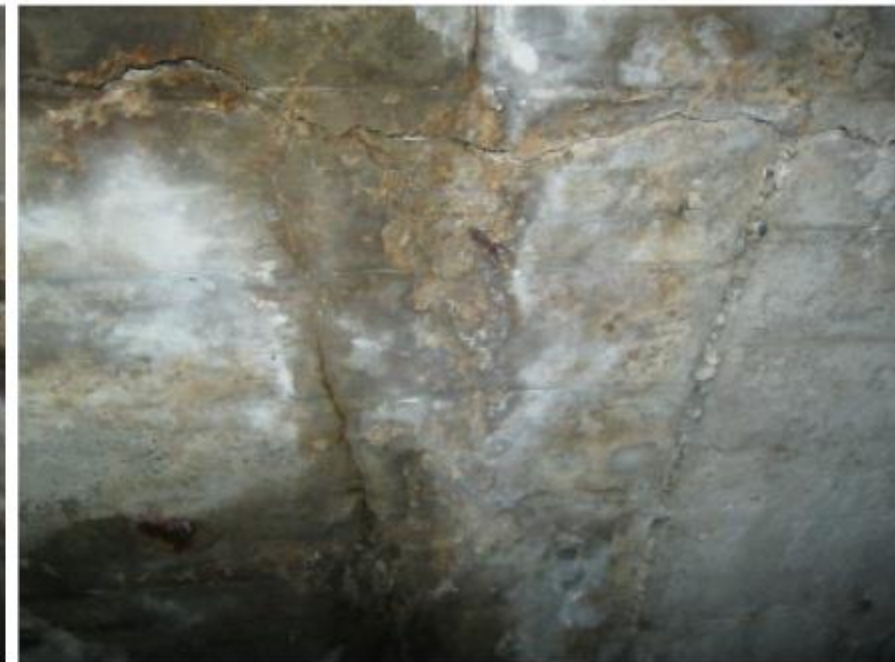
Figure 2-10. Ellipse: crack with infiltration

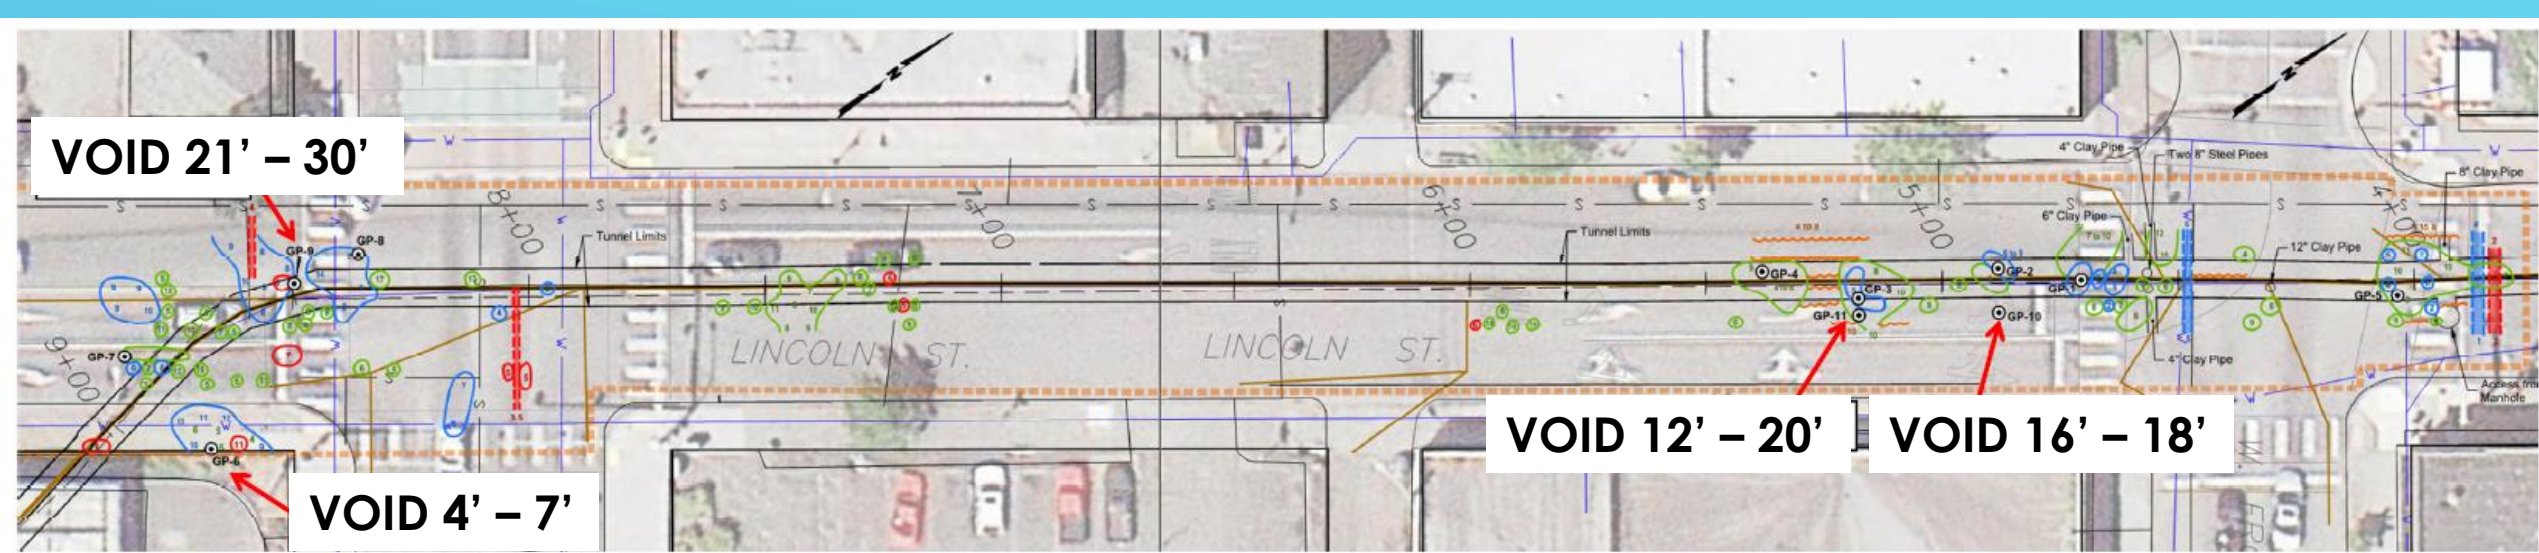
Figure 3-1. Void locations at the intersection of Lincoln Street and First Street

- ▶ High potential for structural failure
- ▶ 2012 – 8 foot sinkhole was identified and filled at the intersection of Lincoln St and First St
- ▶ 2014 – Ground penetrating radar identified 4 voids in close proximity to the culvert
- ▶ 2019 – Inspection of culvert revealed no significant changes in condition
