## Transit trips and fueling of Ferry "Raunefjord"

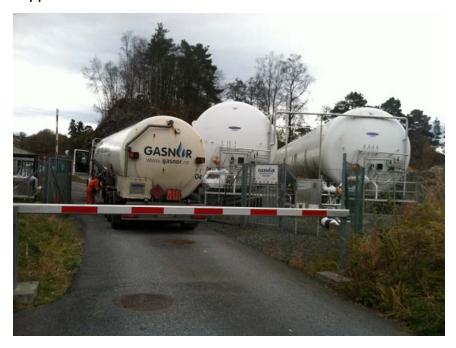
Shore tanks being refueled by tanker truck

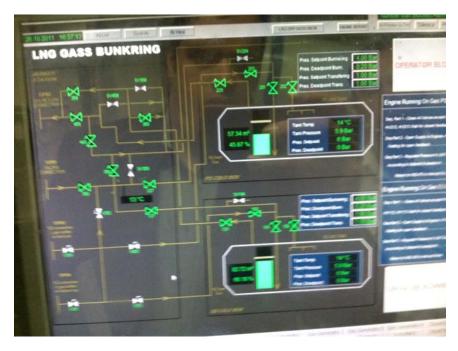
There were no shore personnel associated with the operation and a automated control console at the shore station monitored shore LNG tank conditions and remotely operated shore LNG tank valves. Most impressive was an embedded screen check off list that required keying in that certain things had been done before one could move to the next step.

Bunkering control screen
