At-Risk Crossings - Priority Ranking Associated With Oil By Rail Legislative Study

UTC Staff Recommended Crossing Projects – In Priority Order with Estimated Costs

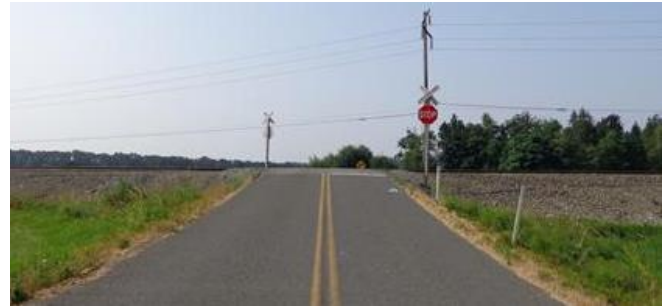
Cross buck and stop sign at 48th Avenue NW, Snohomish County (#1)

1.	48 th Avenue NW Snohomish County USDOT #084683A Leg Districts: 10 / 2 <i>(Photo on page 1)</i>	N/A	Install active warning devices consisting of shoulder-mounted Light Emitting Diode (LED) lights and gates. \$350,000	This crossing is on BNSF’s mainline. The crossing is currently protected by cross bucks and stop signs. Both approach grades are over five percent ¹ , which limits sight distance down the tracks; makes it difficult for some vehicles (e.g. large trucks and vehicles towing trailers) to stop, restart, and quickly clear the crossing; and may cause some vehicles such as low-boy semi-trailers to high-center and get stuck on the tracks. There have been two accidents at the crossing in the past five years and three accidents in the past 10 years.

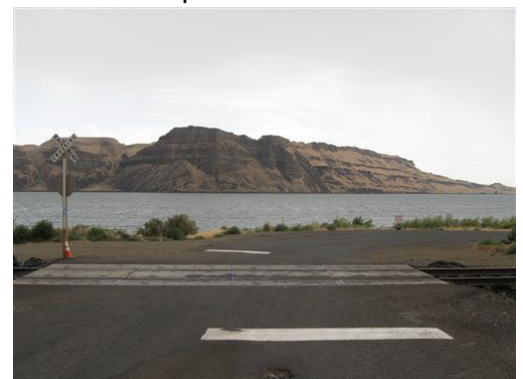
South approach Port Kelley Road, Walla Walla Co.

9.	Port Kelley Road Walla Walla County USDOT #844389C Leg Districts: 16 / 4 <i>(Photo on page 1)</i>	Improve asphalt approaches; Waiting for cost estimate from the County. \$Unknown	Install active warning devices consisting of shoulder-mounted LED lights and gates. \$350,000	This crossing is on UP's mainline. The crossing is currently protected by cross bucks and stop signs. There is limited sight distance on the north approach, which means a motorist cannot see far enough down the tracks to make an informed decision on whether or not it is safe to cross. The exposure factor (number of trains per day x vehicles per day which represents the number of opportunities for a collision everyday) is over 1500. There is high seasonal truck and recreational vehicle traffic.

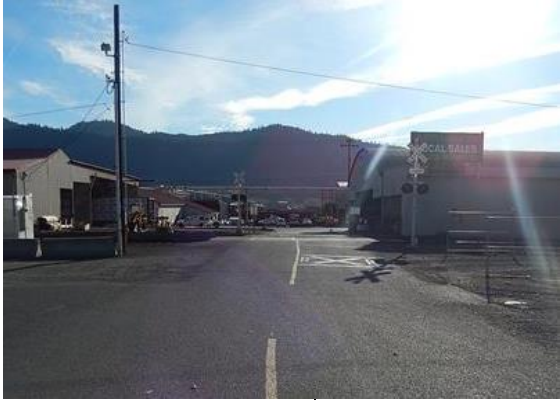
2.	Walnut Street City of Bingen Klickitat County USDOT #090168N Leg Districts: 14 / 3

Replace incandescent bulbs with LED. \$2,500	Upgrade active warning devices to shoulder-mounted LED lights and gates. \$350,000 Install concrete crossing surfaces. \$128,000²	This crossing is a triple-track crossing on BNSF’s mainline. The crossing is currently protected by flashing lights with no gates. A motorist must stop when lights are flashing but may proceed across the crossing when he or she perceives it to be safe. The three tracks make it a very wide crossing, which takes longer to clear than a standard one-track crossing. In addition, multiple track crossings can deceive a motorist into thinking it is safe to cross when one train passes, not realizing there is a second train approaching on another track. The exposure factor is over 4000 (number of trains per day x number of vehicles per day, which represents the number of opportunities for a collision every day). There is limited sight distance in one quadrant, which means a motorist cannot see far enough down the tracks to make an informed decision on whether or not it is safe to cross. There is a warehouse on one side of the tracks and large trucks may stop in the roadway, either loading or unloading from the warehouse. When this happens, vehicles may stop on the tracks and be unable to move when a train approaches.

² There is \$22.9M in funding for a grade-separated crossing in Bingen at SR 14 (L2220062), which may affect the operation and configuration of the existing Walnut St crossing.

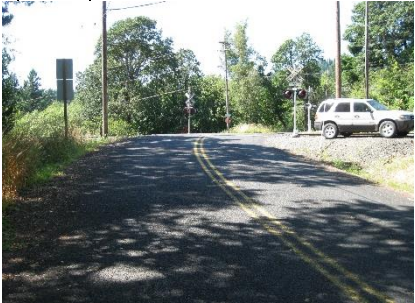
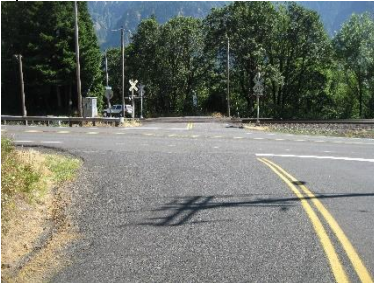
4.	Butler Road Skamania County USDOT #090135B Leg Districts: 14 / 3

This crossing is a double-track crossing on BNSF's mainline. The crossing is currently protected by flashing lights. A motorist must stop when lights are flashing but may proceed across the crossing when he or she perceives it to be safe. The second track is used for trains to pass each other when going in opposite directions. In addition, multiple track crossings can deceive a motorist into thinking it is safe to cross when one train passes, not realizing there is a second train approaching on another track. The south approach grade is over five percent which limits sight distance down the tracks and makes it difficult for some vehicles (e.g. large trucks and vehicles towing trailers) to stop, restart, and quickly clear the crossing. There is limited sight distance, which means a motorist cannot see far enough down the tracks to make an informed decision on whether or not it is safe to cross. This crossing is in close proximity to SR-14 with limited containment, meaning vehicles stopped at the tracks for a train can back up to SR-14. This makes it difficult to enter or exit the highway safely. Likewise, cars stopped to enter SR-14 can back up over the tracks, unable to clear the tracks if a train approaches.

Replace incandescent bulbs with LED. \$2,500 Replace cross bucks and 2-track signs. \$350 Move stop signs to expand containment; WSDOT completing within current budget. \$-0-	Relocate bungalow. \$100,000 Install concrete crossing surfaces. \$104,000

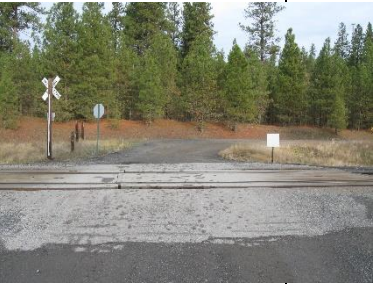
5.	Scribner Road West Spokane County USDOT #065968K Leg Districts: 6 / 5

Install constant-flashing solar-powered LED light stop signs. \$20,000	Close crossing. ⁴ \$154,000	This crossing is on BNSF's mainline. The crossing is currently protected by cross bucks and stop signs. The south approach grade is over five percent, which limits sight distance down the tracks and makes it difficult for some vehicles (e.g. large trucks and vehicles towing trailers) to stop, restart, and quickly clear the crossing. In addition, the approach is on a gravel/dirt road, making it even more difficult for vehicles to stop, restart and clear the crossing.

⁴ BNSF intends to file a petition to close the crossing. If no petition is filed by July 2016, commission staff will re-evaluate. Estimated costs include \$60,000 for UTC regulatory costs plus \$94,000 for railroad to physically remove crossing.

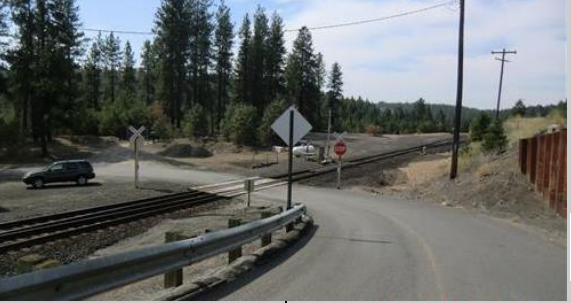
6.	Scribner Road East ⁵ Spokane County USDOT #095923K Leg Districts: 6 / 5

Install constant-flashing solar-powered LED light stop signs. \$20,000	Close crossing. ⁶ \$154,000	This crossing is on BNSF's mainline. The crossing is currently protected by cross bucks and stop signs. The south approach grade is over five percent, which limits sight distance down the tracks and makes it difficult for some vehicles (e.g. large trucks and vehicles towing trailers) to stop, restart, and quickly clear the crossing. In addition, the approach is on a gravel/dirt road, making it even more difficult for vehicles to stop, restart and clear the crossing. There is limited sight distance on the north approach, which means a motorist cannot see far enough down the tracks to make an informed decision on whether or not it is safe to cross. This crossing is in close proximity to Cheney-Spokane Highway with limited containment, meaning vehicles stopped at the tracks for a train can back up the highway. This makes it difficult to enter or exit the highway safely. Likewise, cars stopped to enter the Cheney-Spokane Highway can back up over the tracks, unable to clear the tracks if a train approaches.

⁵ Scribner Road East was added because the staff site visit revealed this crossing met the same risk factors as Scribner Road West. Crossings are 0.1 miles apart.

⁶ BNSF intends to file a petition to close the crossing. If no petition is filed by July 2016, commission staff will re-evaluate. Estimated costs include \$60,000 for UTC regulatory costs plus \$94,000 for railroad to physically remove crossing.

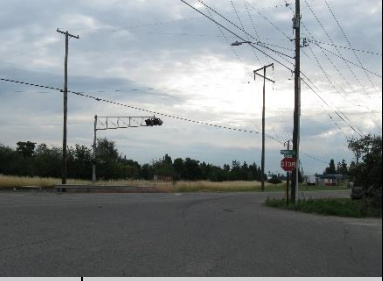
7.	Wellesley Avenue Spokane County USDOT #662535B Leg Districts: 4 / 5

N/A	Upgrade active warning devices to shoulder-mounted lights and gates and median barriers. \$364,000 Install LED hard-wired active advance warning signs. \$50,000	This crossing is on UP's mainline. The crossing is currently protected by flashing lights. A motorist must stop when lights are flashing but may proceed across the crossing when he or she perceives it to be safe. Almost 4000 vehicles travel this road every day. The tracks cross the highway at a severe angle, making it difficult for a motorist to look down the tracks and see a train approaching. There is limited sight distance, which means a motorist cannot see far enough down the tracks to make an informed decision on whether or not it is safe to cross. There is an intersection with Railroad Avenue between crossing signals, which is confusing and poses a potential conflict with other traffic at the crossing.

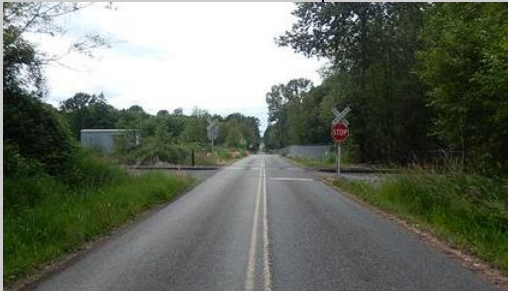
10.	Brown Road Whatcom County USDOT #096134P Leg Districts: 42 / 1

N/A	Install active warning devices consisting of shoulder-mounted LED lights and gates \$350,000 Install concrete crossing surfaces. \$52,000 Widen roadway approach lanes to at least 11 feet. \$120,000	This crossing is on a BNSF branch line. The crossing is currently protected by cross bucks and stop signs. The exposure factor (number of trains per day x number of vehicles per day which represents the number of opportunities for a collision everyday) is over 1500. The crossing is on a very narrow road with heavy use by BP Cherry Point refinery for employees and deliveries.

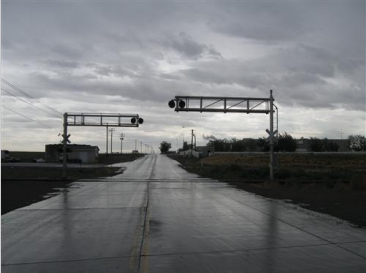
13.	Dodd Road Walla Walla County USDOT #844396M Leg Districts: 16 / 4

N/A	Upgrade active warning devices to shoulder-mounted LED lights and gates. \$350,000	This crossing is on UP's mainline. The crossing is currently protected by flashing lights. A motorist must stop when lights are flashing but may proceed across the crossing when he or she perceives it to be safe. The exposure factor (number of trains per day x number of vehicles per day which represents the number of opportunities for a collision everyday) is over 4000.

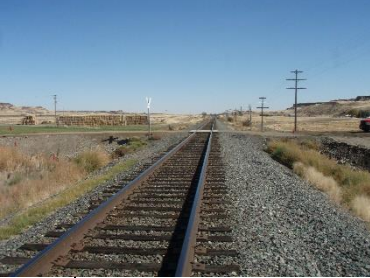
14.	Charles Tobin Road Whitman County USDOT #814028R Leg Districts: 9 / 4

N/A	Reduce approach grades; County completed work within current budget 10/2015. \$-0-	This crossing is on UP's mainline. The crossing is currently protected by cross bucks and stop signs. Both approach grades are over five percent, which limits sight distance down the tracks; makes it difficult for some vehicles (e.g. large trucks and vehicles towing trailers) to stop, restart, and quickly clear the crossing; and may cause some vehicles such as low-boy semitrailers to high-center and get stuck on the tracks. In addition, there is limited sight distance, which means a motorist cannot see far enough down the tracks to make an informed decision on whether or not it is safe to cross.
	TOTAL	INTERIM \$85,350	LONG-TERM \$10,192,000
