# TOUCHET RIVER BRIDGE

## WAITSBURG

Bridge Replacement Budget Request

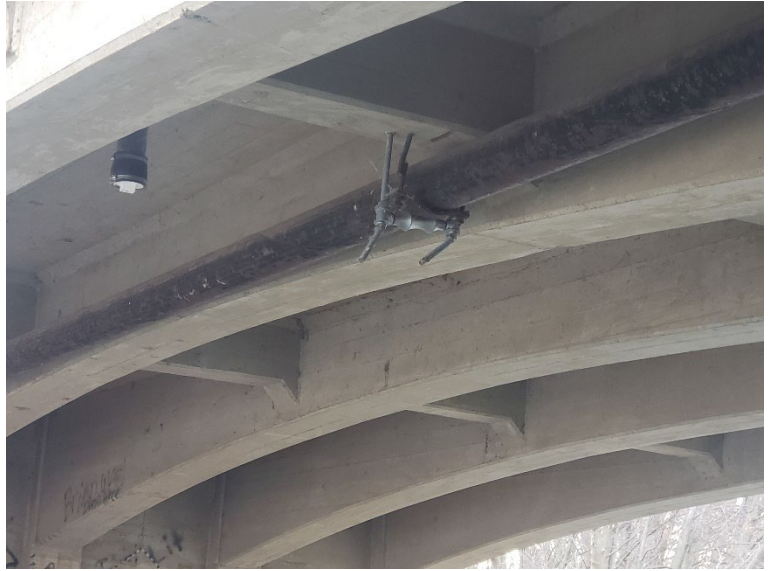
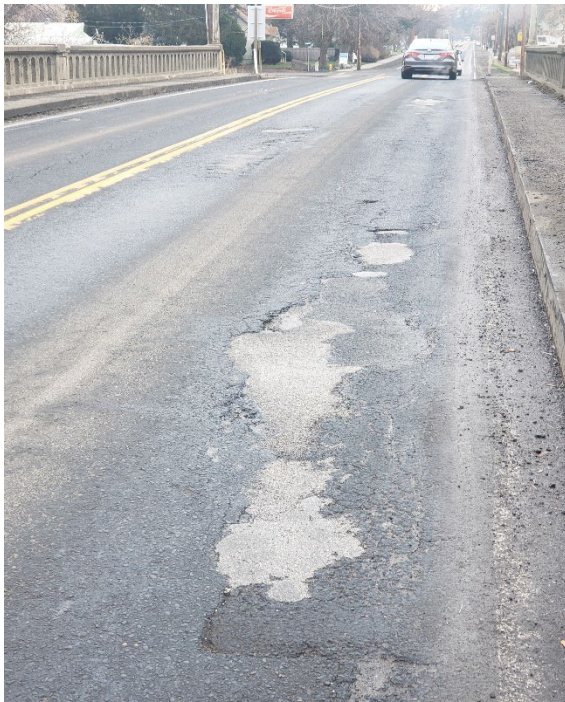
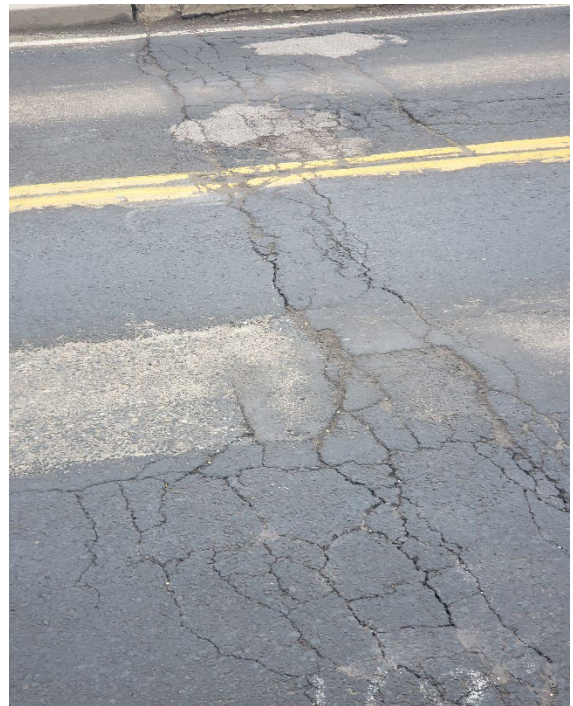
The Touchet River Bridge on Highway 12 in Waitsburg is approaching a Century of use and needs replaced. The bridge no longer functions as designed for today's traffic loads and volumes; with over a million vehicles passing over it every year. Additionally, the bridge also creates a choke point for flood debris during highwater events, adding to flooding concerns for the City of Waitsburg. The deck is spalling and cracking and there is chunk out of it on the upstream side. Our waterline that hangs under the bridge was also damaged slightly in prior years flood event and vegetation and other debris has piled up on the upstream side of the bridge.

The City of Waitsburg would like to partner with WSDOT on this project in order to see the bridge replaced with a modern single span bridge that eliminates, traffic, pedestrian and flood concerns.

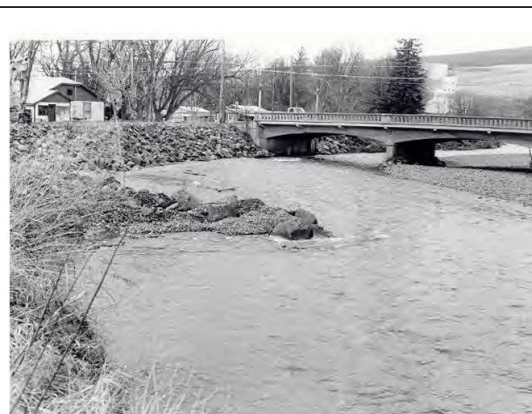
**Figure 5.** 1996 photo of Preston Avenue Bridge, facing downstream, RM 44.3. Note: there are 3 spans to this bridge and the two left spans are free of brush. Photo courtesy of Loyal Baker and the Times.

Based on current conditions and older photos, little to no maintenance has been done to the bridge since at least 1996. The two eastern sections are now completely blocked with vegetation and sediment, leading to a reduced river channel flow that puts addition pressure on the western levee and bridge abutment.

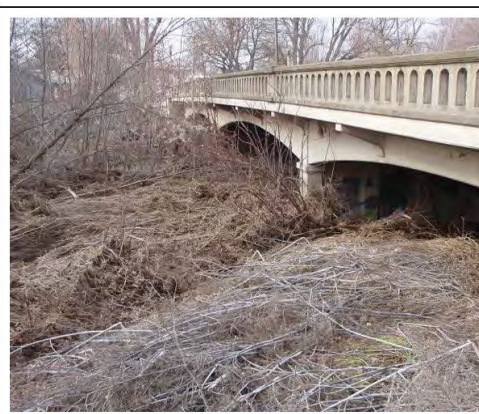
**Figure 6.** Shows Preston Ave Bridge Facing West, Note the Two Tiers are Full of Brush and Silt, 2/19/09. Photograph by Alex Amonette
